**IN THE GENERAL DIVISION OF
THE HIGH COURT OF THE REPUBLIC OF SINGAPORE**

[2022] SGHC 32

District Court Appeal No 25 of 2021

JUDGMENT

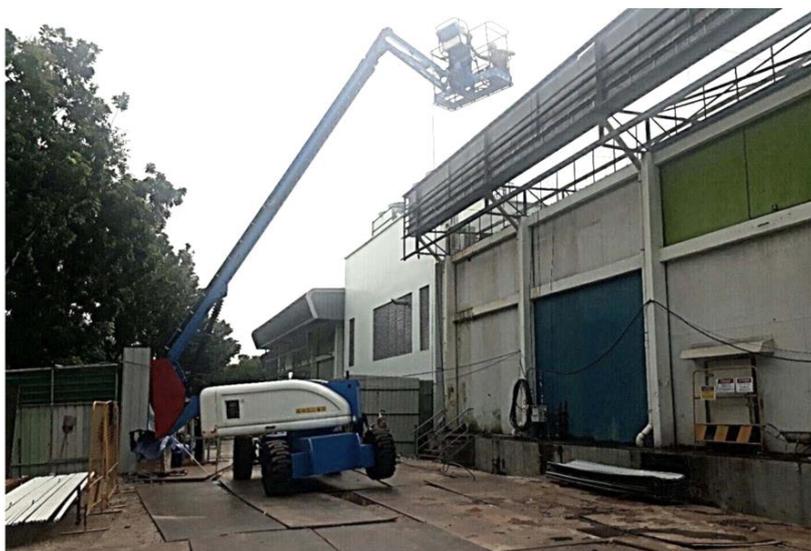
9 I shall refer to this photograph as the tilting incident photograph. It shows the Boom Lift after it had shut off and before the workers were rescued. Only the upper boom had been deployed. It had been elevated to an angle of about 45 to 50 degrees. One wheel had lost contact with the ground.

- (a) Only the upper boom has been deployed and the lower boom remains at rest.
- (b) The upper boom has been fully extended.
- (c) The upper boom's angle of elevation is about 45 to 50 degrees.
- (d) One wheel has lifted off the ground.
- (e) The Boom Lift is resting on multiple loose steel plates laid upon the ground.

and there is no reason not to accept that evidence, although it is not mentioned by the district judge. However, the tilting incident photograph does appear to show that the steel plates themselves are not entirely level. This was acknowledged by Mr Khairul during cross-examination.⁴³

34 The conclusion that can be drawn from the tilting incident photograph in the light of the other evidence adduced is that the ground was generally level, such that the possible presence of any declivity under one wheel did not prevent the Boom Lift from commencing and initially continuing operation.

37 Similarly, it is not obvious from the tilting incident photograph, which shows one wheel lifted off the ground during operation, that the Boom Lift is of unsatisfactory quality. This is especially so given that the tilting incident photograph shows that only the upper boom was deployed, it was fully extended and raised to an angle of 45 to 50 degrees, contrary to what the seller contends is proper use. To establish that the Boom Lift was of unsatisfactory quality, there would need to be expert opinion to the effect that there ought to be no need for deployment of the lower boom before the Boom Lift was used for work at this height. The buyer did not adduce any expert evidence on the tilting incident. Its expert did not offer an opinion on it. He explained in cross-examination that he was only "briefly informed" about it but did not know the details.⁴⁴
