IN THE COURT OF APPEAL OF THE REPUBLIC OF SINGAPORE

[2023] SGCA 20

Court of Appeal / Civil Appeal No 45 of 2022

JUDGMENT

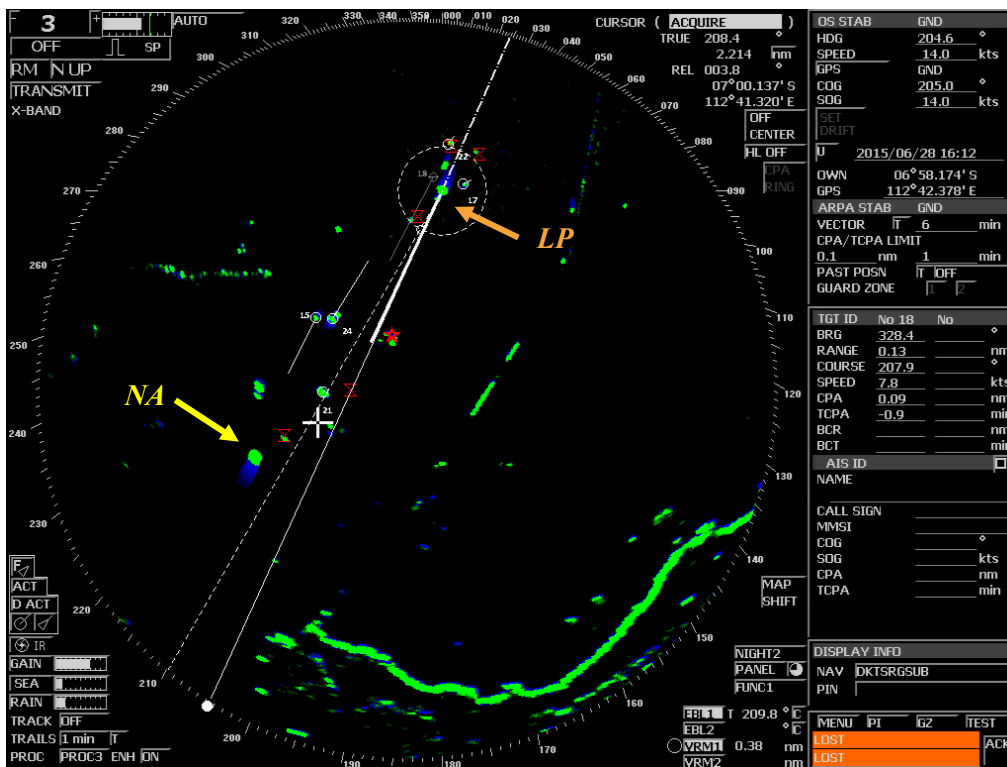
26 At this stage, each vessel was on the port side of the other’s course over ground (“COG”) line. This is illustrated partly by the following screengrab from the LP’s X-Band radar taken at 23:12:21 hours. To give effect to the port-to-port passing agreement, it would have been clear that both vessels needed to make course alterations to starboard.

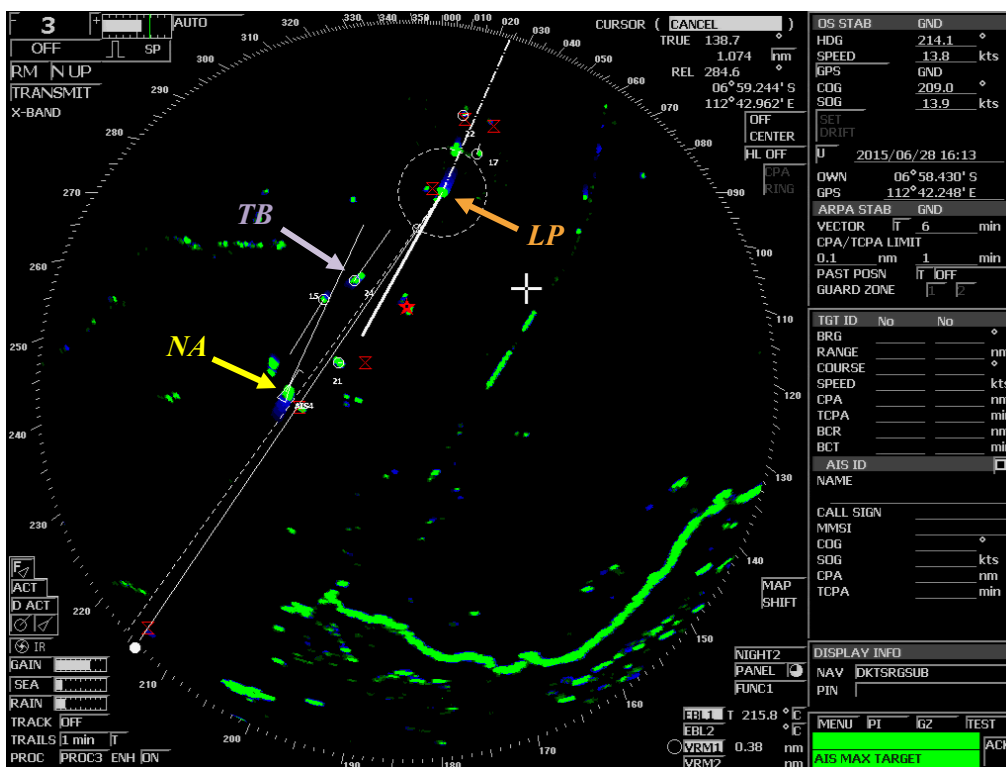
31 The following screengrab from the *LP*’s X-Band radar, taken at 23:13:36 hours, reflects the relative positions of the vessels when the starboard-to-starboard passing agreement was reached with the *TB*:

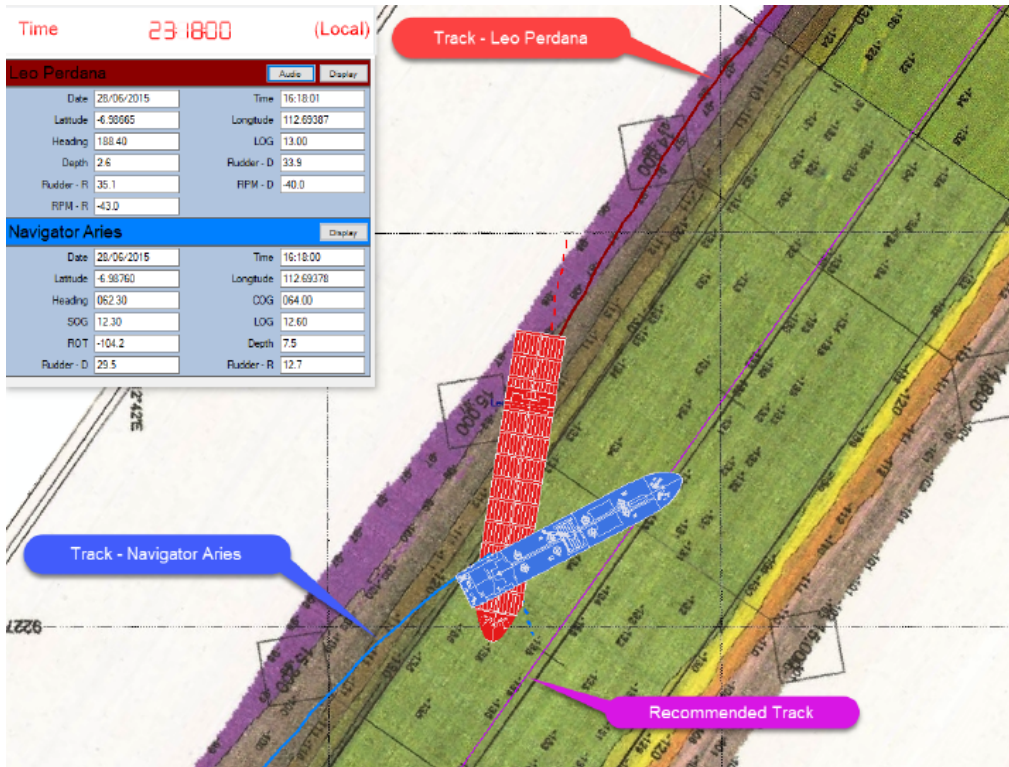
36 The manoeuvres undertaken by both vessels ultimately failed to prevent the collision from occurring. By 23:17:30 hours, the vessels were only about 0.1nm apart and closing at a combined speed of about 28 knots. The vessels’ initially uneventful voyages underwent a sea change with the port sheer, with the *LP*’s heading changing from 222.9° at the time the sheer commenced at 23:16:46 hours, to 198.6° at the time of the collision at 23:17:51 hours (*ie*, she went to port by 24.3°). At 23:17:51 hours, the *LP*’s bow struck the *NA*’s port side at an acute angle. The angle of the blow is illustrated in the AIS plot below:

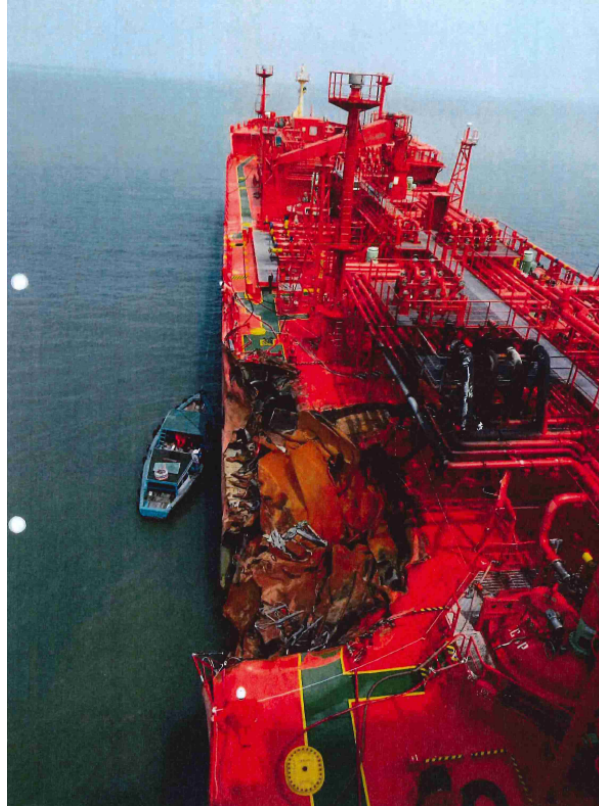
37 The actual impact of the blow is also captured in this photograph of the *NA* taken post-collision:

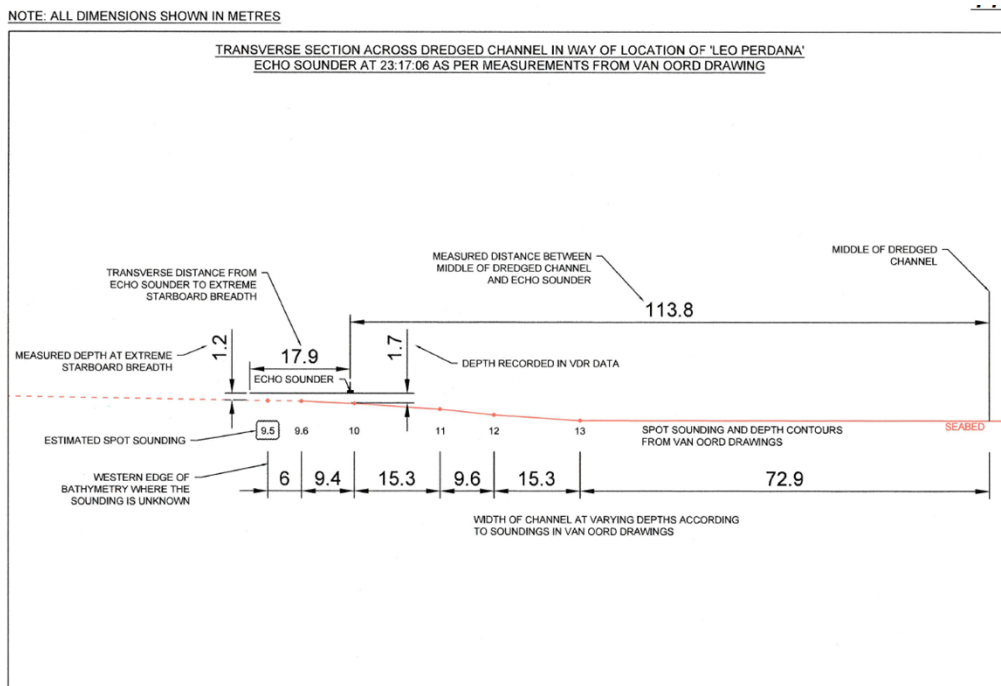
on her echo transducer data. The parties’ experts submitted the following diagram, showing a UKC of 1.2m on the *LP*’s starboard side and 1.7m UKC on her port side. We accept that this differential provides the conditions for bow cushion effect to arise.

To be clear, the port sheer occurred at 23:16:46 hours. The reason the above diagram refers to measurements taken at 23:17:06 hours is that there was a lag of about 20 seconds between the time the *LP*’s bow would have crossed a given spot on the seabed, and the time her echo transducer would have crossed that same spot. This is because her echo transducer was some 147m aft of the forward perpendicular. A 20 second adjustment was thus applied to estimate the *LP*’s UKC at 23:16:46 hours.

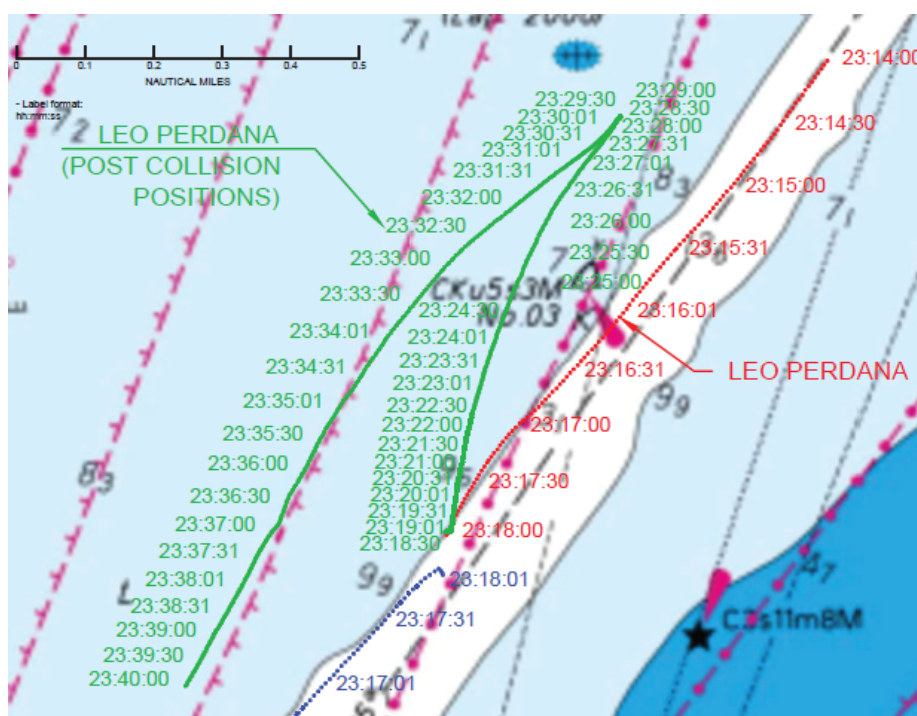
139 We address each observation in turn, starting with the *LP*’s post-collision track. Using the *LP*’s AIS positions, the appellant’s experts had mapped out her post-collision track as follows (in green):

We mention for completeness that this map does not reflect the Strait’s bathymetry *post*-dredging. It is based on BA Chart 975, which was published in 2012 prior to the dredging activity in 2015. However, nothing really turns on this observation in our analysis of Rule 9, although we will return to this in relation to Rule 2 (see [158] below).

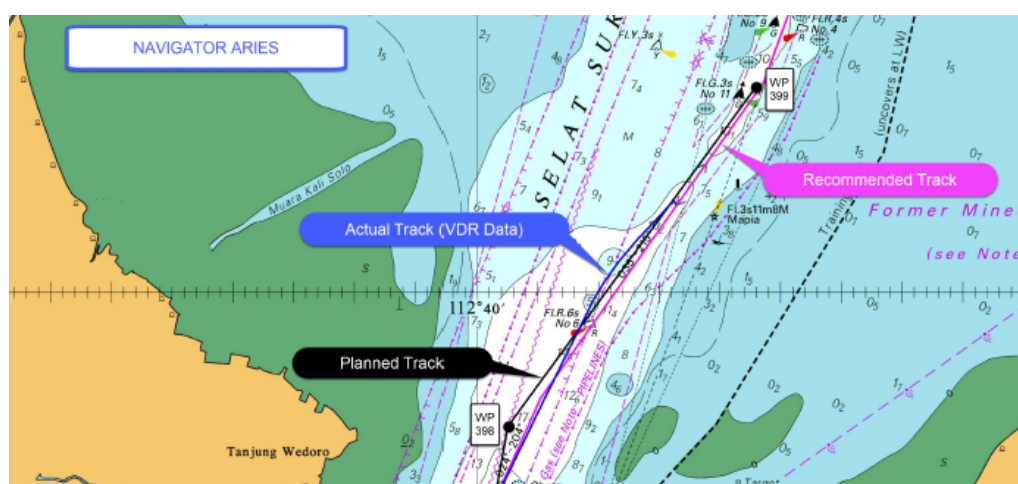
177 At about 23:10 hours, the *NA* reached the charted point where the axis of the Recommended Track changed from 024° to 035° (see the diagram at [178] below). But the *NA* did not adjust her course to starboard, and kept her COG around 026° – some 9° port off the Recommended Track. She remained to the west of the Recommended Track up to the time of collision. Comparing her heading and COG, it appeared that she was unable to overcome a drift angle of some 6° to port due to the prevailing northerly current.

178 From the following chart prepared by Capt Hart, it can be seen that the *NA*’s actual track (in blue) cut across that of the Recommended Track (in pink) as she travelled northwards, with her actual track remaining to the west of the Recommended Track up to the point of collision (where the blue line terminates):

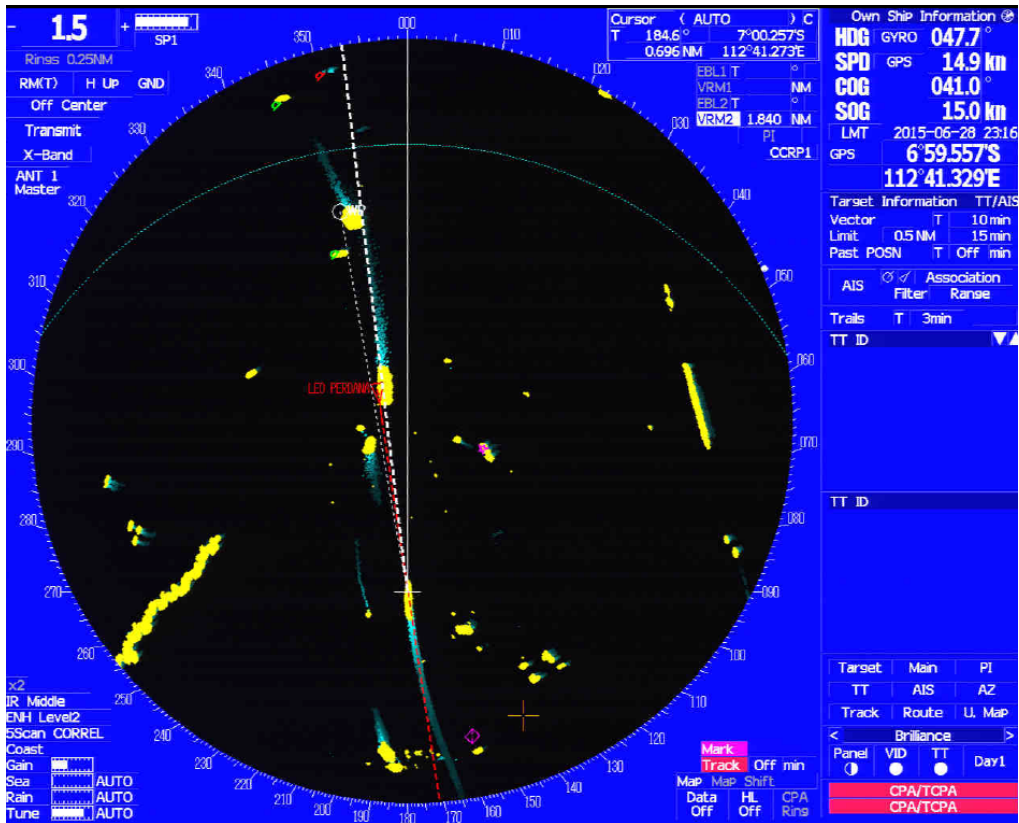
196 From their courses, the vessels also appeared to be shaping to complete the red-to-red passing. As described above at [101], the vessels’ red sidelights had opened and green sidelights had closed by 23:15 to 23:16 hours, indicating that each vessel was off the other’s port bow. The point is made starker when one compares the following radar screengrabs from the *NA*’s X-Band radar (which is set to head-up mode with relative motion, and a 1.5nm range). The first screengrab, taken at 23:16:14 hours, shows the *LP*’s radar echo lying on the *NA*’s COG line (*ie*, the white dashed line extending from the *NA*).

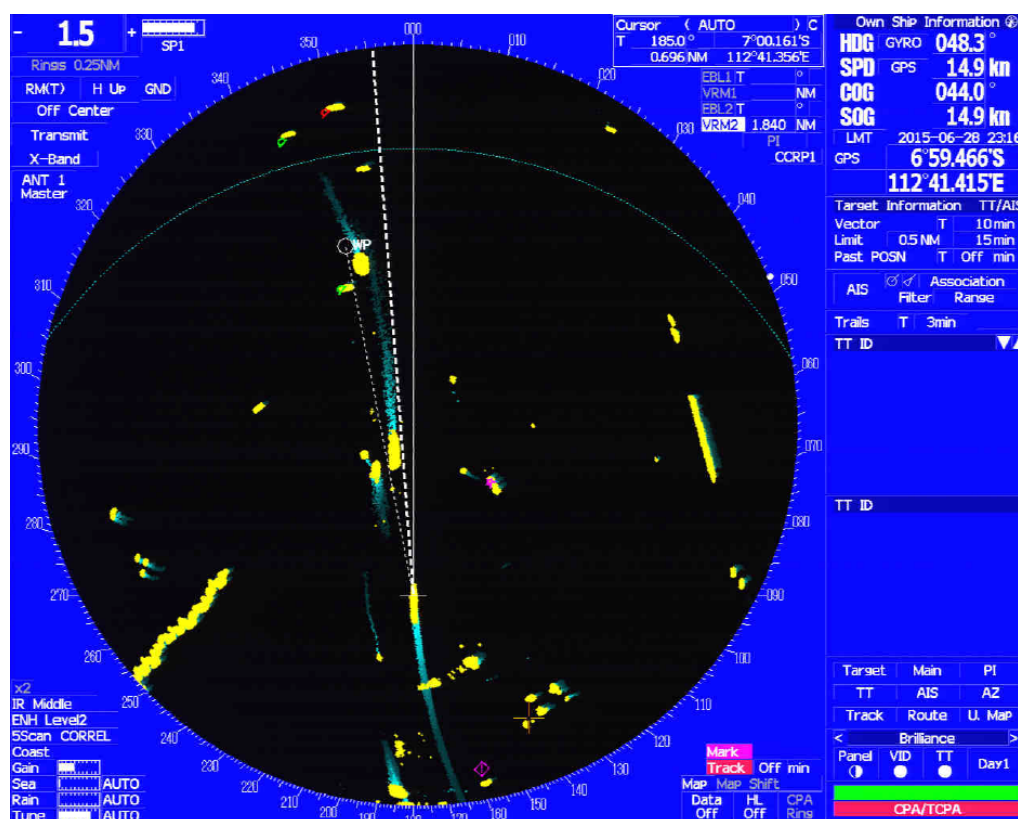
197 The screengrab taken 30 seconds later at 23:16:44 hours (reproduced below) shows the *LP*'s radar echo now lying *port* of the *NA*'s COG line, as vessels shaped to pass port-to-port. This was just before the port sheer commenced at 23:16:46 hours.
